The Club at Norwich Inn & Spa
Capital Improvement Project
and Reserve Analysis Report
March 12, 2018

**THE CLUB AT NORWICH INN & SPA
CAPITAL IMPROVEMENT PROJECT AND RESERVE ANALYSIS REPORT**

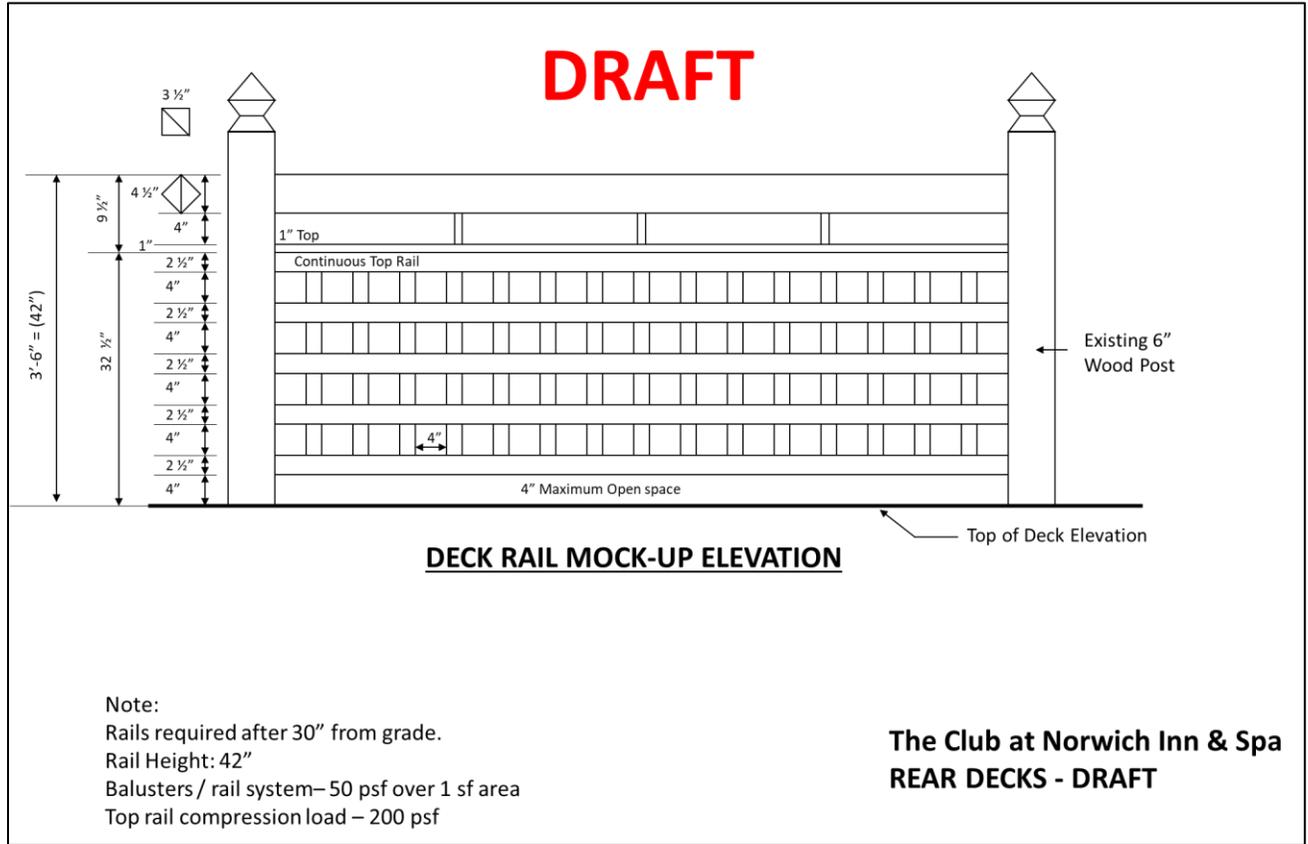
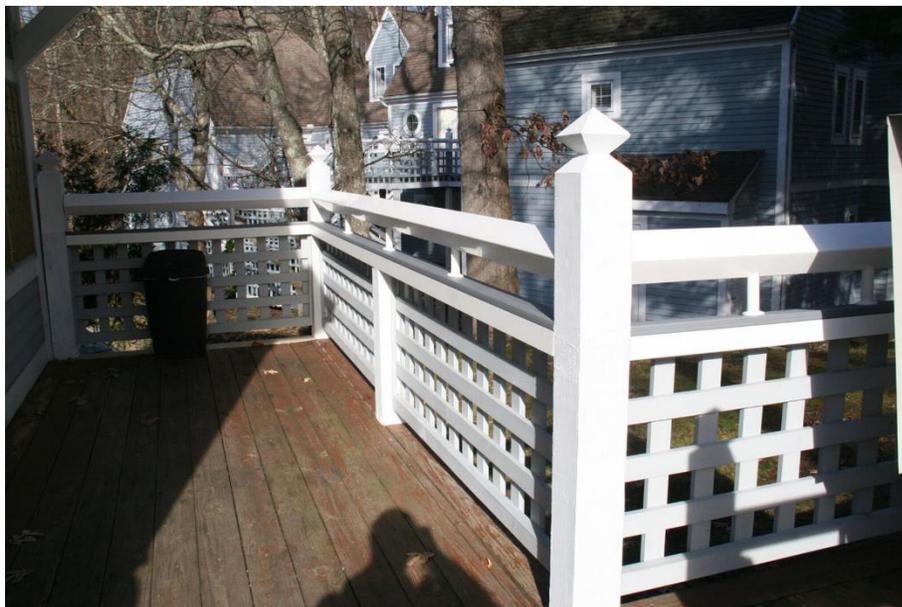
ITEM 4: REAR DECKS - DECK RAIL DESIGN MOCK-UP

The Association constructed this deck rail mock-up at the mailhouse. Use this mock-up as the basis of design for the deck, entrance terrace and stair rail system. See plans and pictures.

2. Support framing and posts to remain.
3. Remove and replace all deck rail systems (between support posts – support posts to remain) and replace with a synthetic material or other synthetic systems that simulate the mock-up and existing rail system. **(Alternate A)**

4. Remove and replace all deck-rail systems (between support posts – support posts to remain) and replace with 1"x3" or 5/4" x 3" pine wood per the mock-up and existing. **(Alternate B)**.
